Menasha Lock and Dam

HAER No. WI-90

**At the confluence of Lake Butte Des Morts
and the Lower Fox River, in the City of Menasha**

WRITTEN HISTORICAL AND DESCRIPTIVE DATA

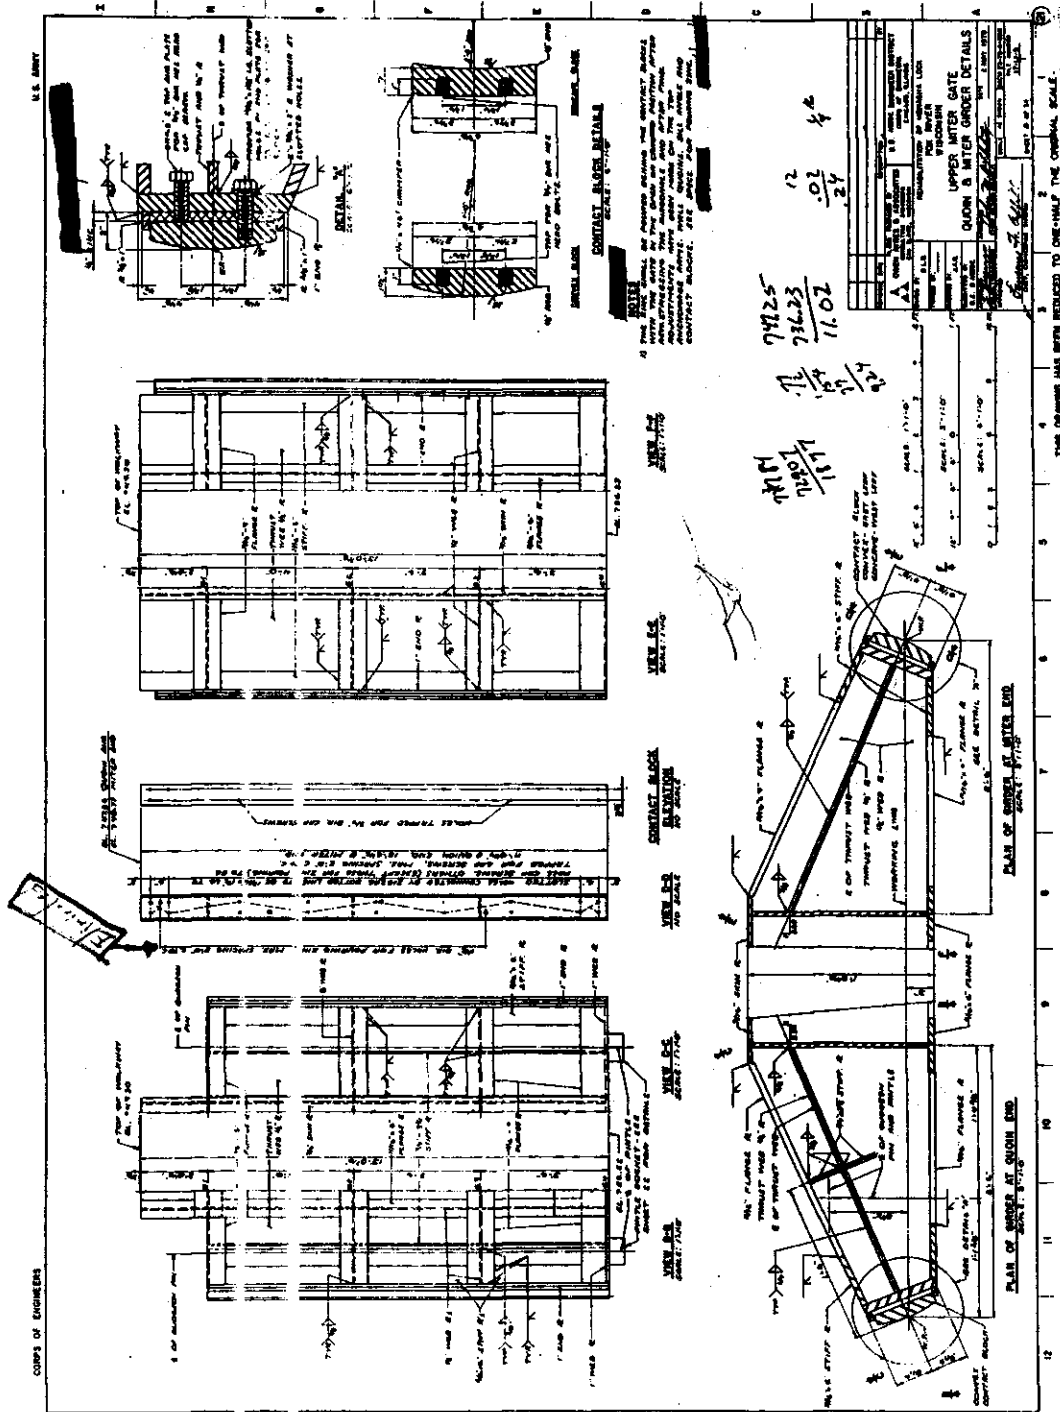
Photocopy of plans for Rehabilitation of Menasha Lock, Upper Miter Gate, Quoin & Miter Girder Details, 1978, File #17-L1-9, sheet 21.

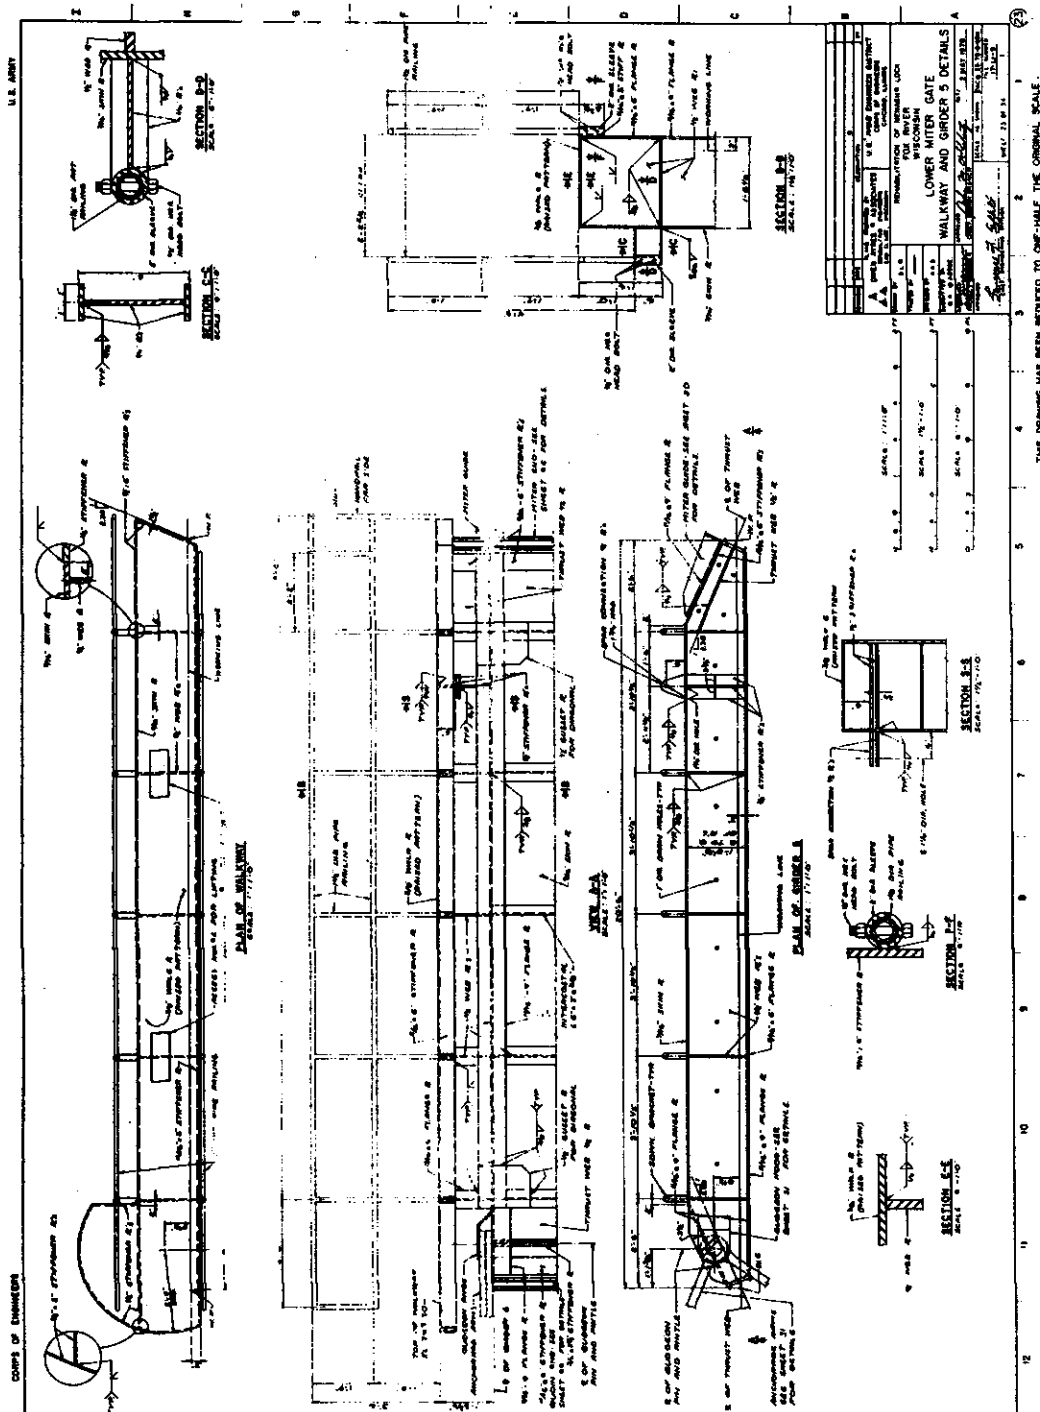
Photocopy of plans for Rehabilitation of Menasha Lock, Lower Miter Gate, Walkway and Girder 5 Details, 1978, File #17-L1-9, sheet 23.

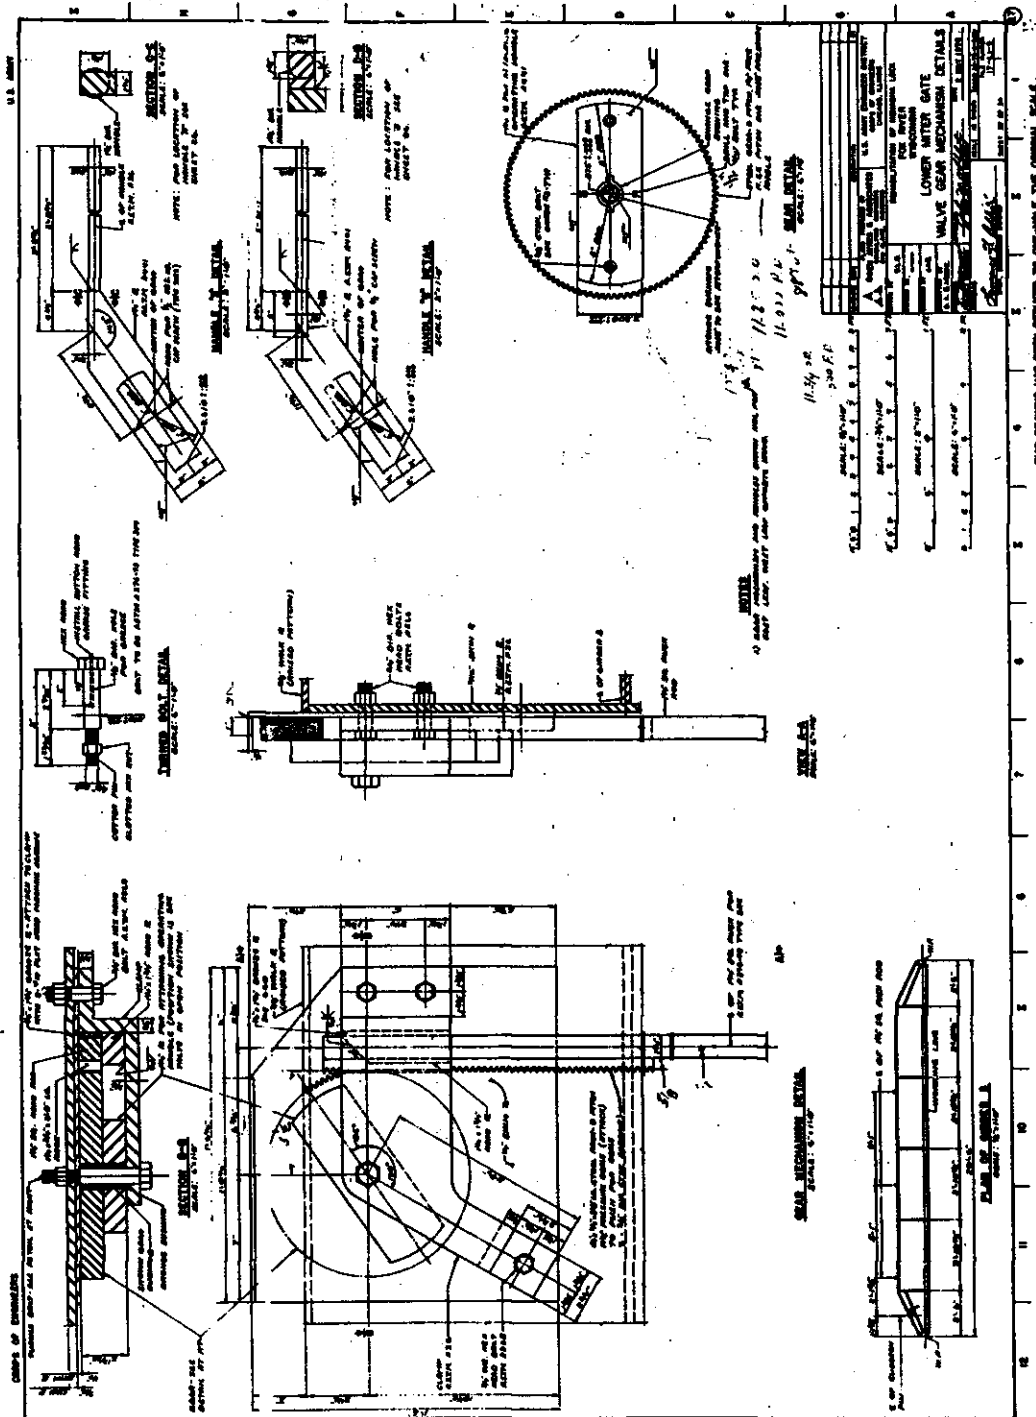
Photocopy of plans for Rehabilitation of Menasha Lock, Lower Miter Gate, Valve Gear Mechanism Details, 1978, File #17-L1-9, sheet 27.

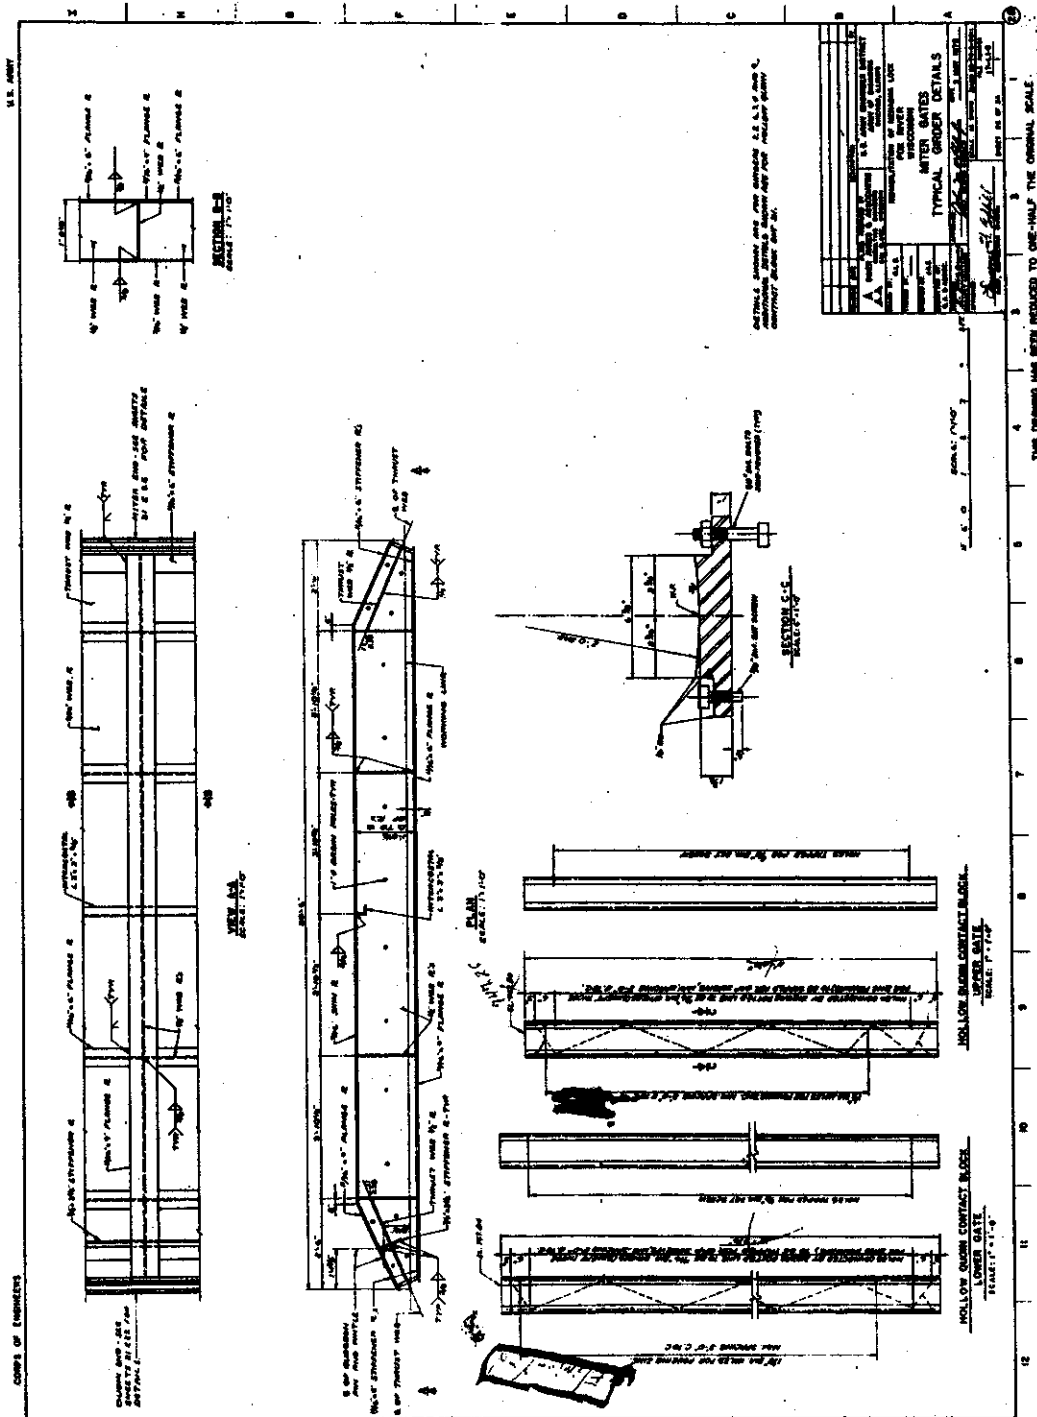
Photocopy of plans for Rehabilitation of Menasha Lock, Miter Gates, Typical Girder Details, 1978, File #17-L1-9, sheet 28.

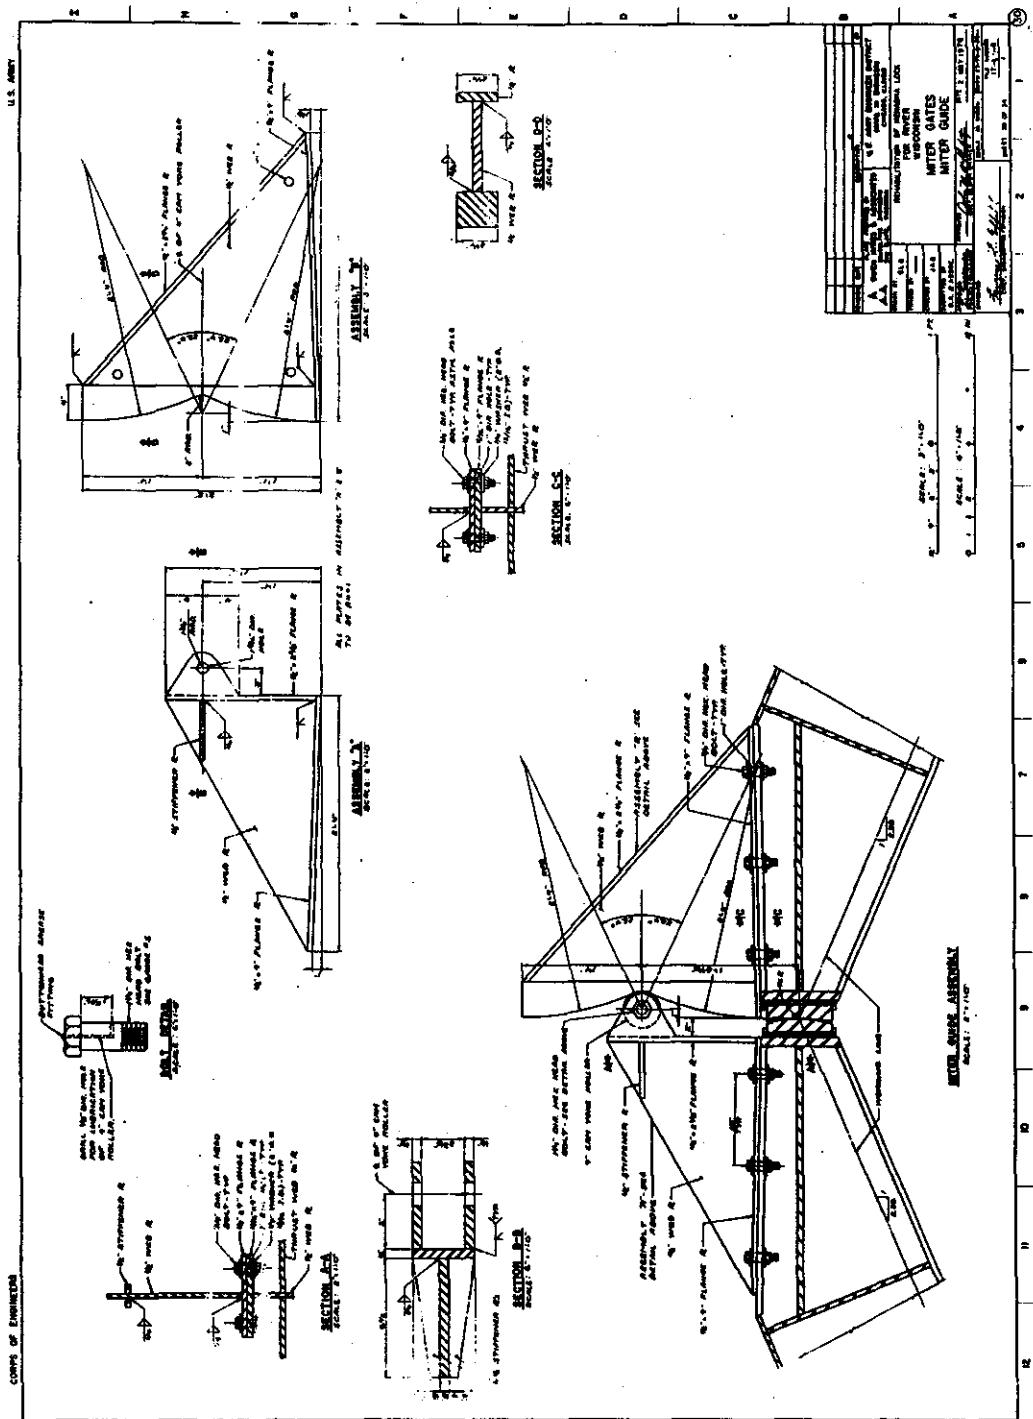
Photocopy of plans for Rehabilitation of Menasha Lock, Miter Gates, Miter Guide, 1978, File #17-L1-9, sheet 30.

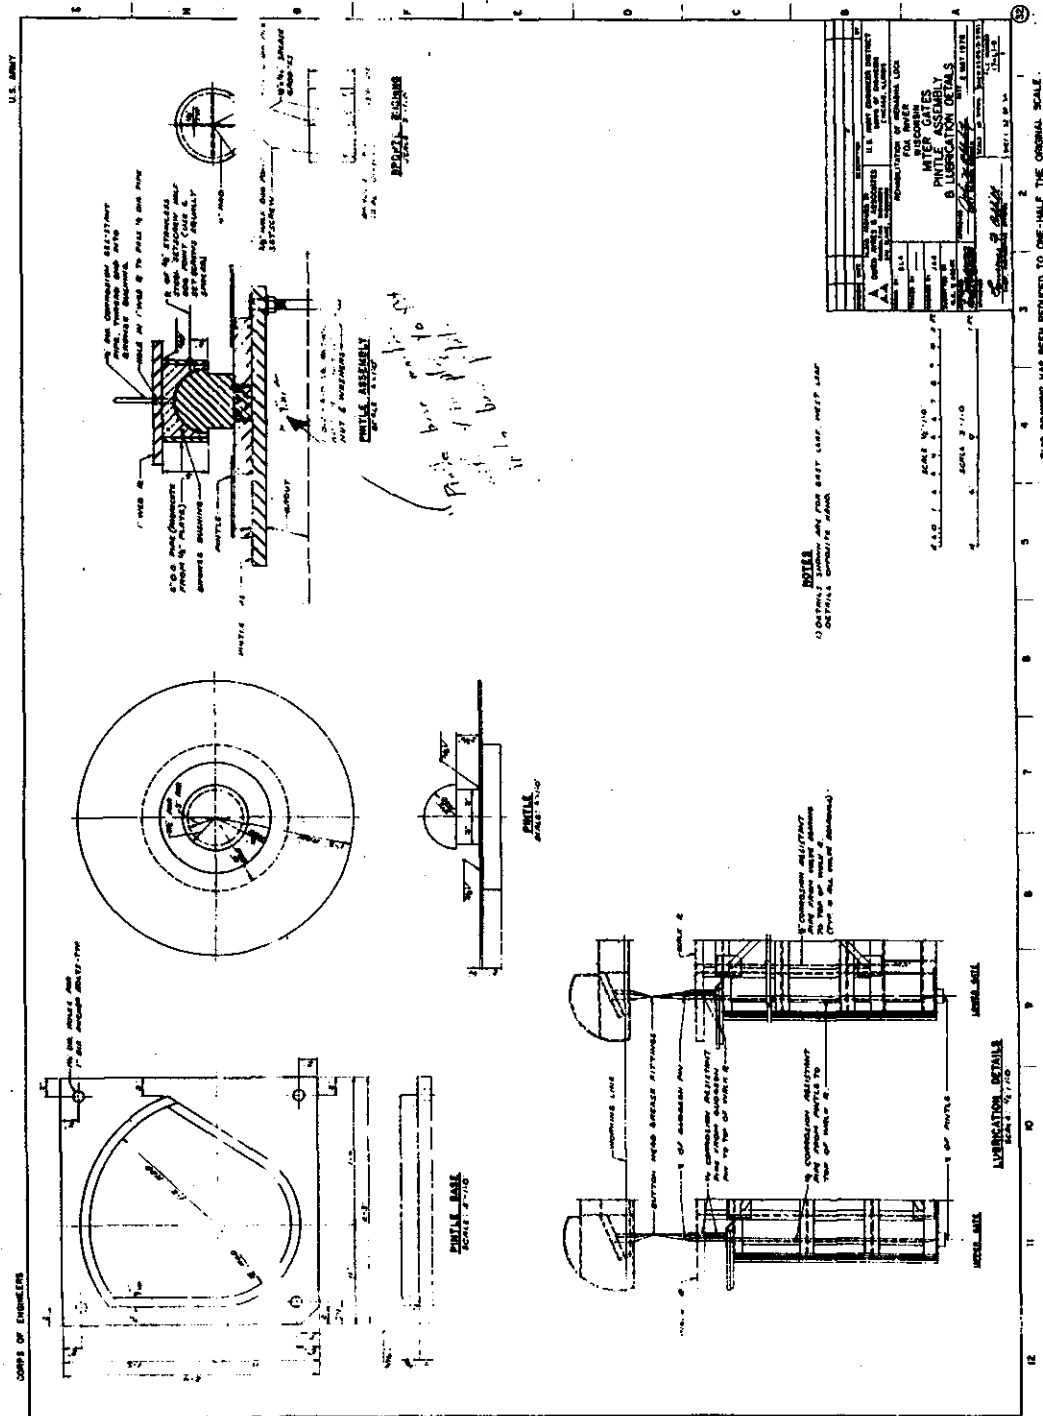
Photocopy of plans for Rehabilitation of Menasha Lock, Miter Gates, Pintle Assembly & Lubrication Details, 1978, File #17-L1-9, sheet 32.
